# Manhole Inspection Summary

Manhole # S69Q\_\_013MH

Insp Date: **4/14/08 10:55 AM**

**Location** Address: **6613 Cardiff Ave.**

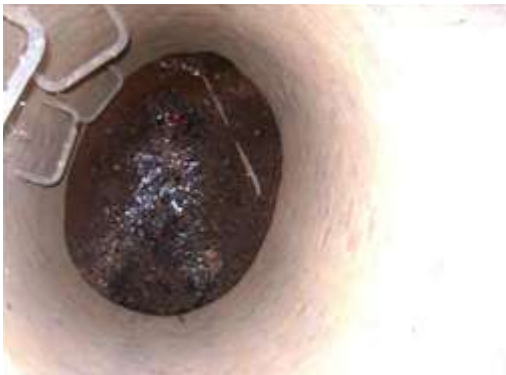
Defect 1

Condition: ☐ Sound ☐ Cracked ☐ Root Intrusion ☐ Deteriorated ☐ Leaks ☒ **Debris**

Debris in Channel

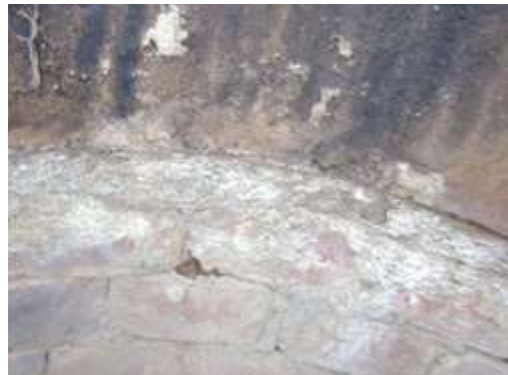
Defect 2

Condition: ☐ Sound ☒ **Cracked** ☐ Root Intrusion ☒ **Loose Brick** ☐ Deteriorated

cracked mortar and infiltration in chimney

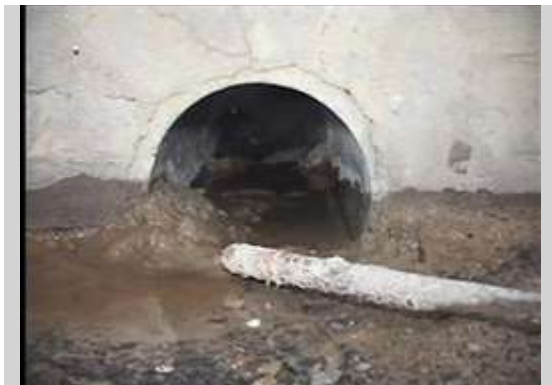
12 O'Clock Outflow

8 in. Circular Gravity Sewer  
Pipe Out @ 12 O'Clock

Deposits: ☐ None ☒ **Mud** ☐ Sludge ☐ Debris ☐ Grease

Silt Depth: **2** (in.) Deposits Extent: **Medium**
